Manhole Inspection Summary

Manhole # S33UU_022MH

Location Address: **2700 MORTON AVE**

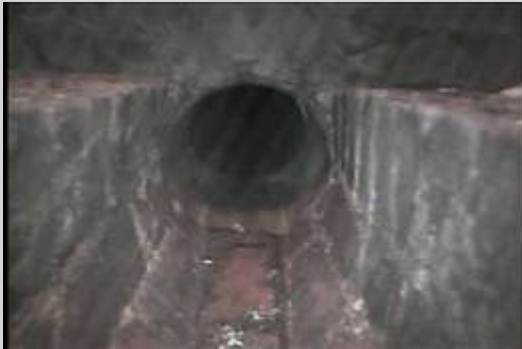
8 in. Circular Gravity Sewer Pipe Out @ 12 O'Clock

Rod and Bar (Angled)

Pipe Material: **Clay** ☐ Pipe Lined

Infiltration: **None** Pipe Seal Cond: **Unknown**
